# TSD File Inventory Index

Facility Name: <u>American Telephone &amp; Telegraph Corporation (see facilities)</u>			
Facility Identification Number: <u>CHD 004 282 703</u>			
<b>A.1 General Correspondence</b>		<b>B.2 Permit Docket (B.1.2)</b>	
<b>A.2 Part A / Interim Status</b>	X	.1 Correspondence	
.1 Correspondence	Y	.2 All Other Permitting Documents (Not Part of the ARA)	
.2 Notification and Acknowledgment	X	<b>C.1 Compliance - (Inspection Reports)</b>	X
.3 Part A Application and Amendments	Y	<b>C.2 Compliance/Enforcement</b>	X
.4 Financial Insurance (Sudden, Non Sudden)	Y	.1 Land Disposal Restriction Notifications	
.5 Change Under Interim Status Requests		.2 Import/Export Notifications	
.6 Annual and Biennial Reports		<b>C.3 FOIA Exemptions - Non-Releasable Documents</b>	
<b>A.3 Groundwater Monitoring</b>		<b>D.1 Corrective Action/Facility Assessment</b>	Y
.1 Correspondence		.1 RFA Correspondence	
.2 Reports		.2 Background Reports, Supporting Docs and Studies

AT&T COLUMBUS, OHIO
<b>FIGURE 2-A</b> FACILITY LAYOUT
<b>PRC</b> ENVIRONMENTAL MANAGEMENT, INC.

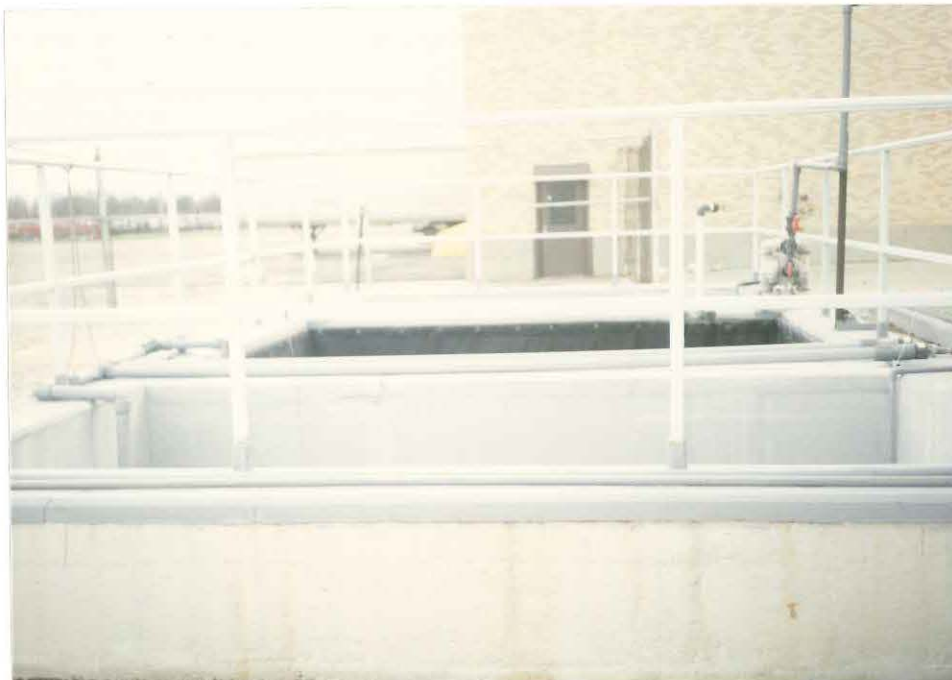
**Photograph No. 4**

**Observations:** During the VSI, the tanks storing waste acid each contained about 3,750 gallons of waste and the third tank contained about 500 gallons of waste sodium hydroxide. The concrete walls of this unit appeared intact. PRC noted no evidence of release (see Photograph No. 4).

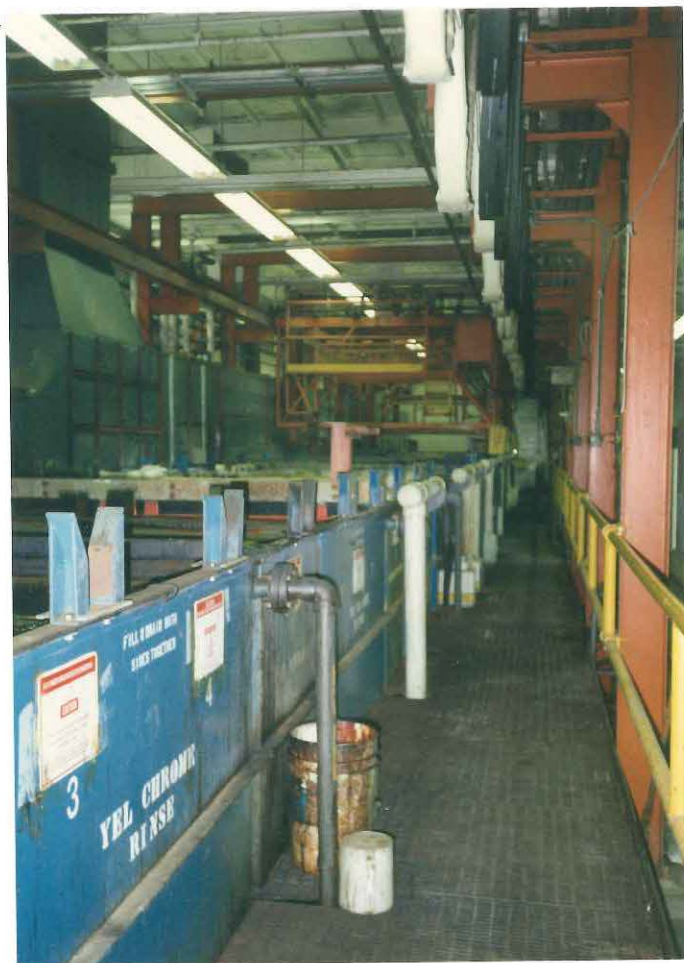
**Photograph No. 7**

**Observations:** The portion of this unit located below the programmable hoist plater and automatic nickel and chrome plater is covered by metal grating and was not visible. The portion of this unit below the acid-tin barrel plating tanks was partially visible during the VSI and contained metal pipes. However, the concrete surface of this unit could not be observed. PRC did hear one of the unit's pumps activate during the VSI (see Photographs No. 7, 8, and 9).

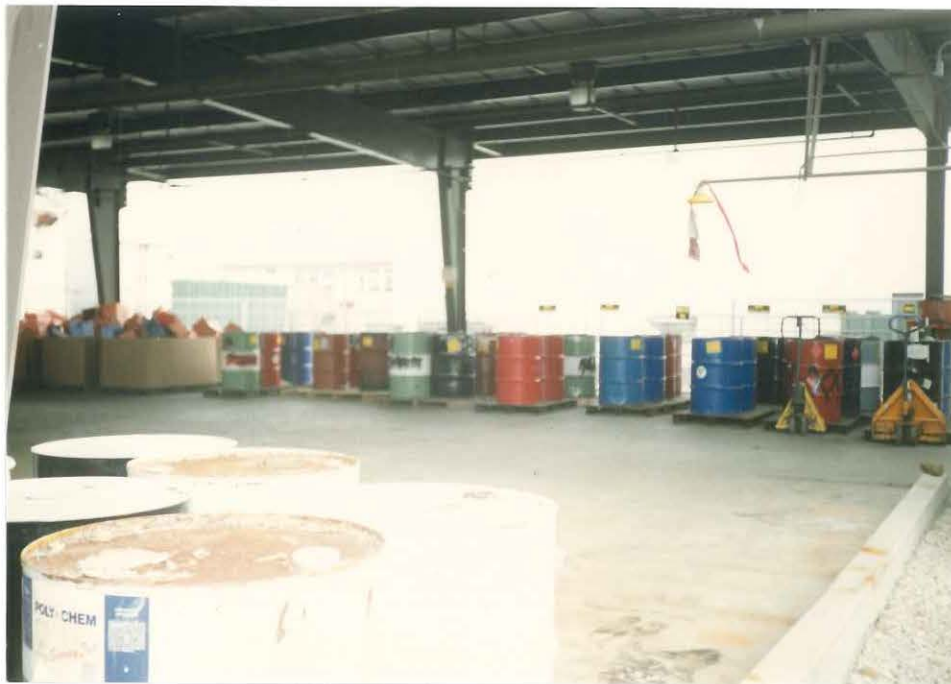
**Photograph No. 10**

**Observations:** The roofed section contained 23 55-gallon drums of used oil; five drums of waste TCE; one drum of waste 1,1,1-TCA; five drums of F002 waste; one drum of F005 waste; one drum of F003 and F005 waste; six drums of solder dross; one drum of waste solder paste; and one drum of PCB waste. The drums were stored on wooden pallets. PRC observed staining of the concrete base of this unit. No cracks in the base were observed (see Photographs No. 10 and 11). The open section contained one partially filled roll-off box containing scrap metal.

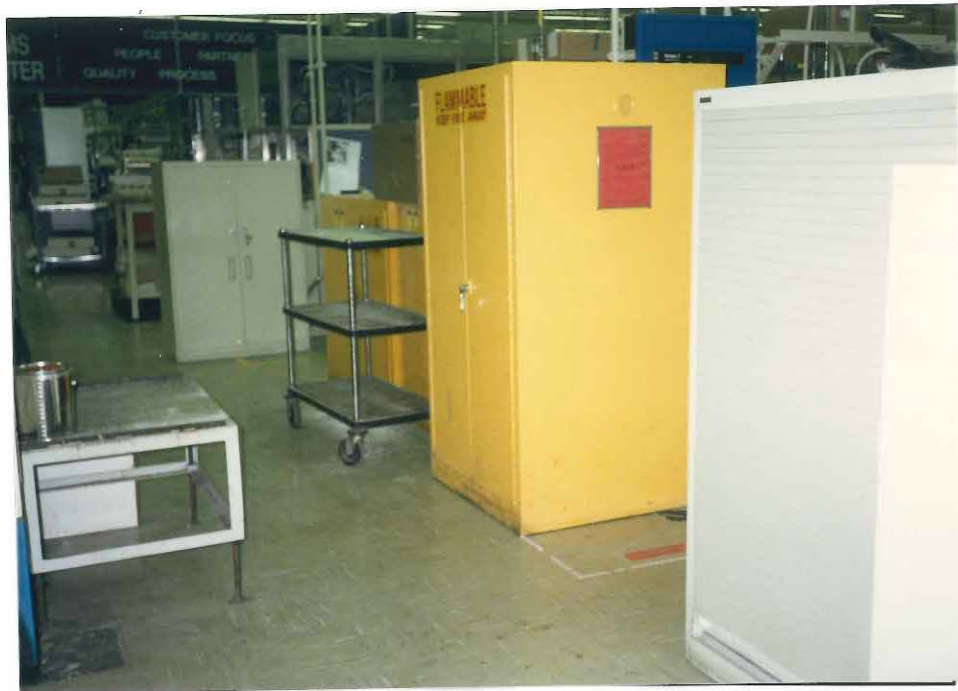
Photograph No. 12

Description: Solder Dross Accumulation Area I (SWMU 6); 55-gallon drum is periodically located within taped section of floor on right side of photograph

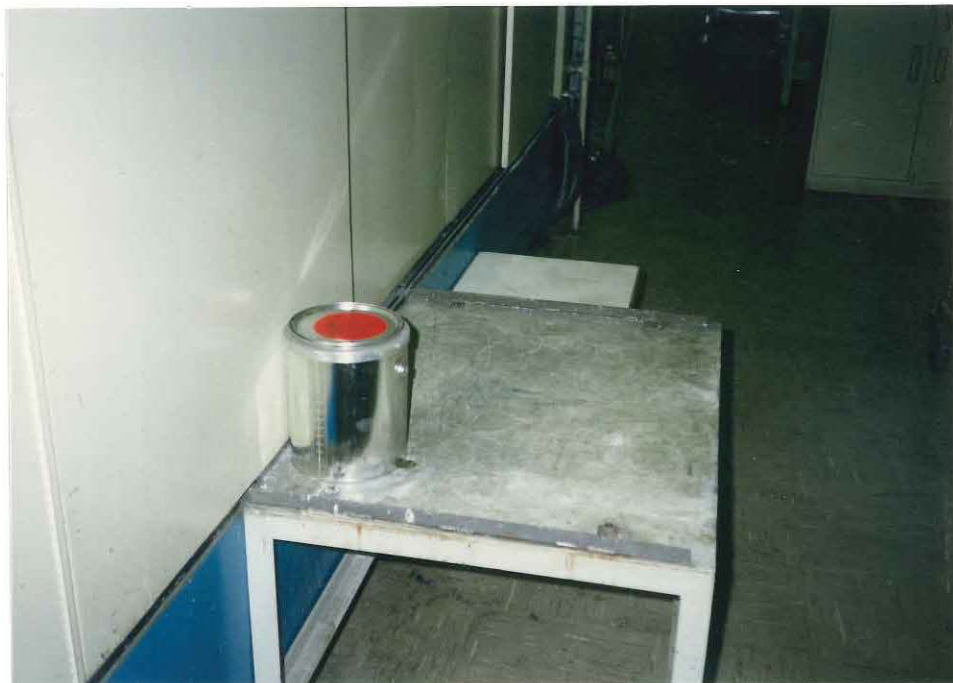
Photograph No. 13

Description: 1-gallon bucket in Solder Dross Accumulation Area II (SWMU 7)

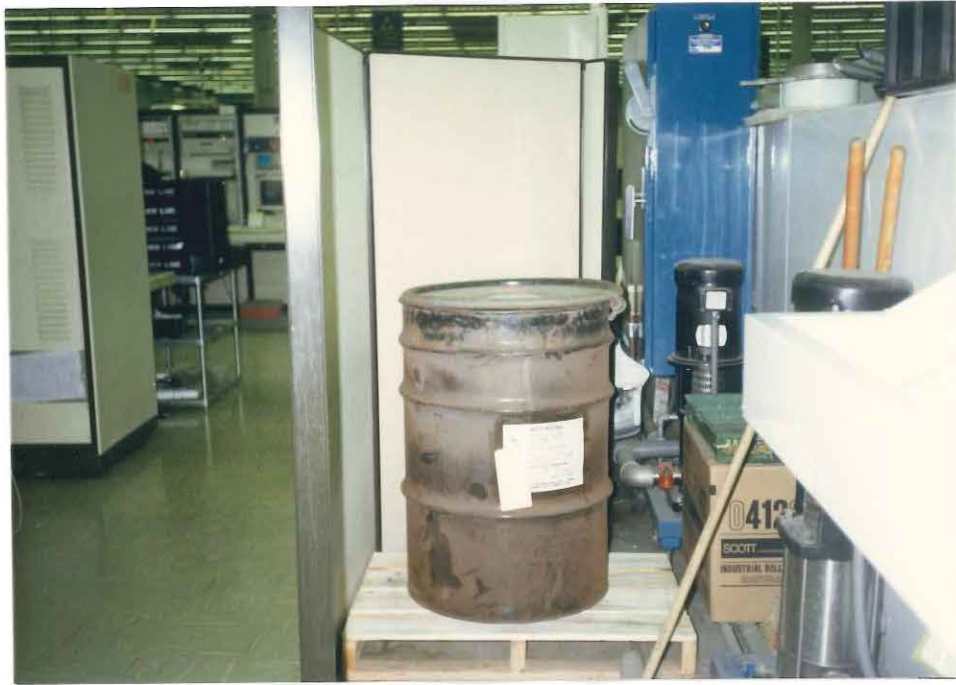
Photograph No. 14  
 Orientation: East  
 Description: 55-gallon drum in SWMU 7

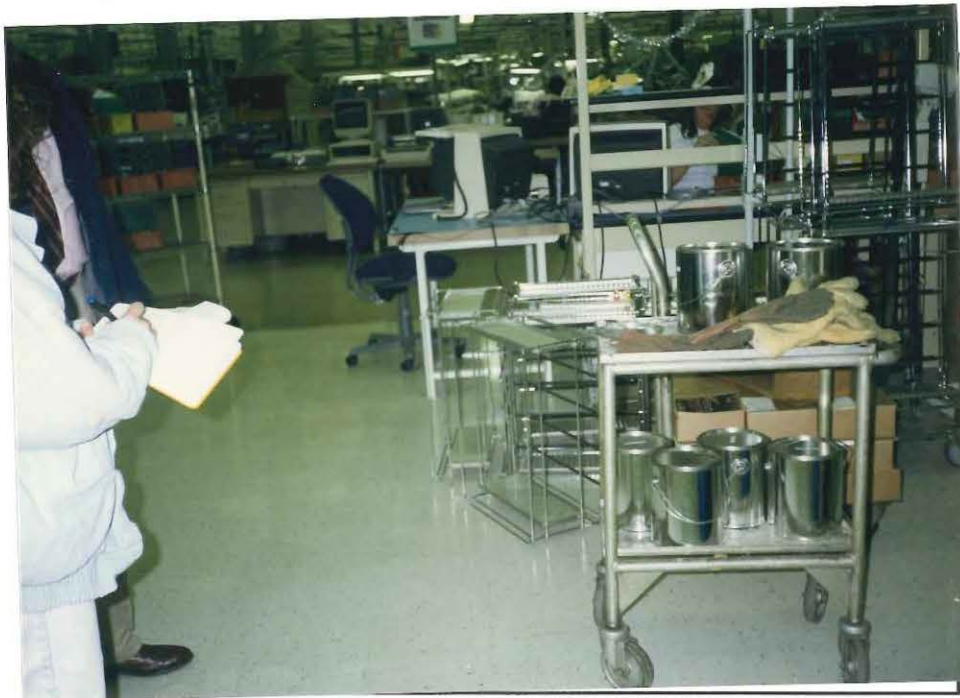
Photograph No. 15  
 Orientation: West  
 Description: Two partially filled 1-gallon buckets in SWMU 8 on top shelf; four buckets on bottom shelf are empty

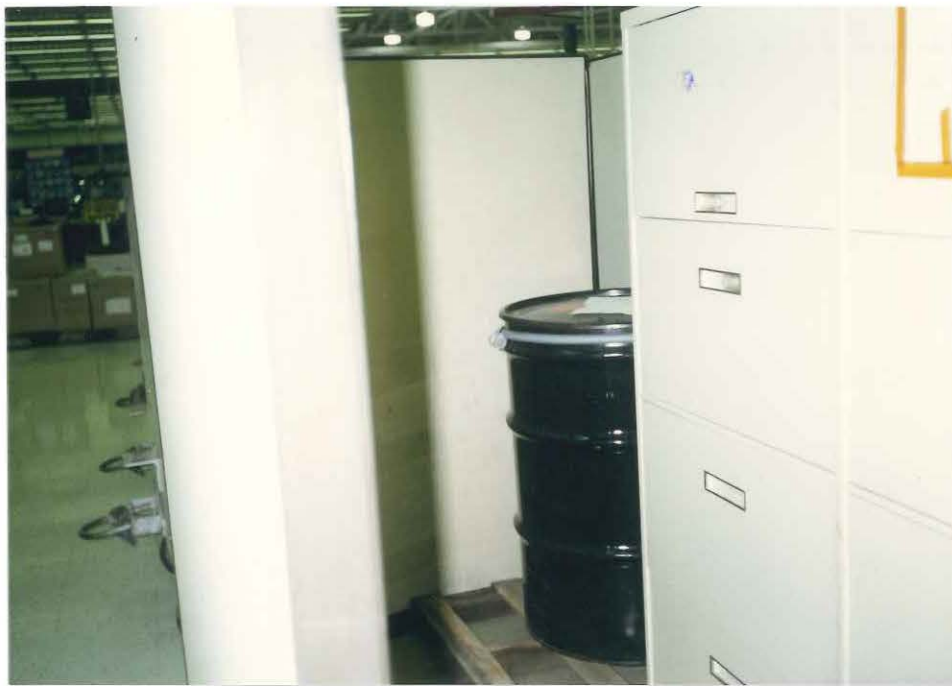
Photograph No. 16  
 Orientation: East  
 Description: 55-gallon drum in SWMU 8

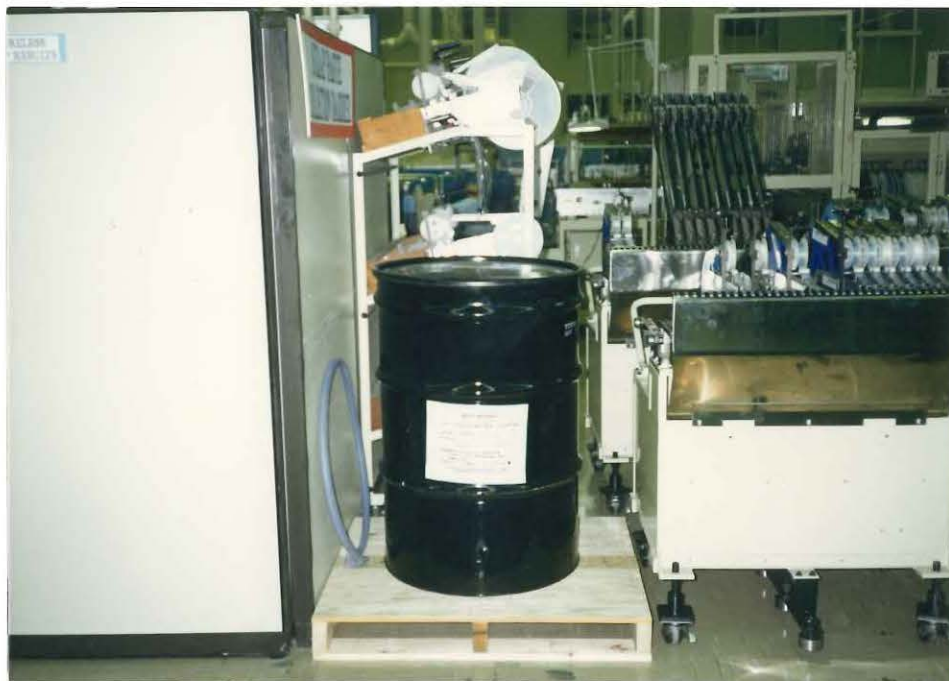
Photograph No. 17  
 Orientation: South  
 Description: 55-gallon drum in Solder Paste Accumulation Area (SWMU 9)

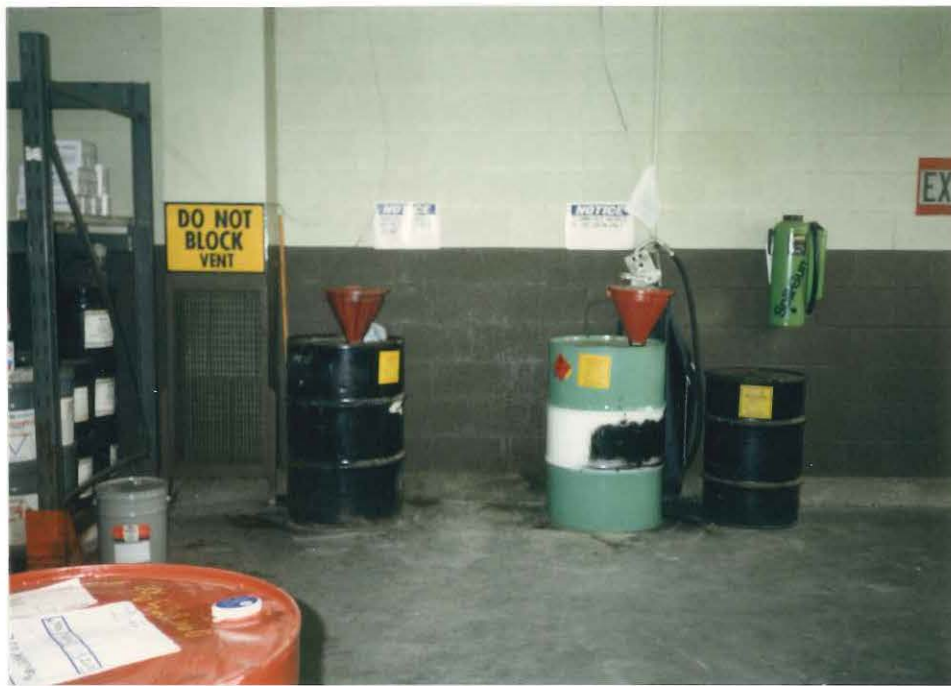
Photograph No. 18

**Observations:** The unit contained one partially filled 55-gallon drum of F003 and F005 wastes, and one partially filled 55-gallon drum of F002 nonflammable wastes. An empty 30-gallon drum was located adjacent to the 55-gallon drums. PRC observed staining on the concrete base of this unit. No cracks in the concrete were observed (see Photograph No. 18).

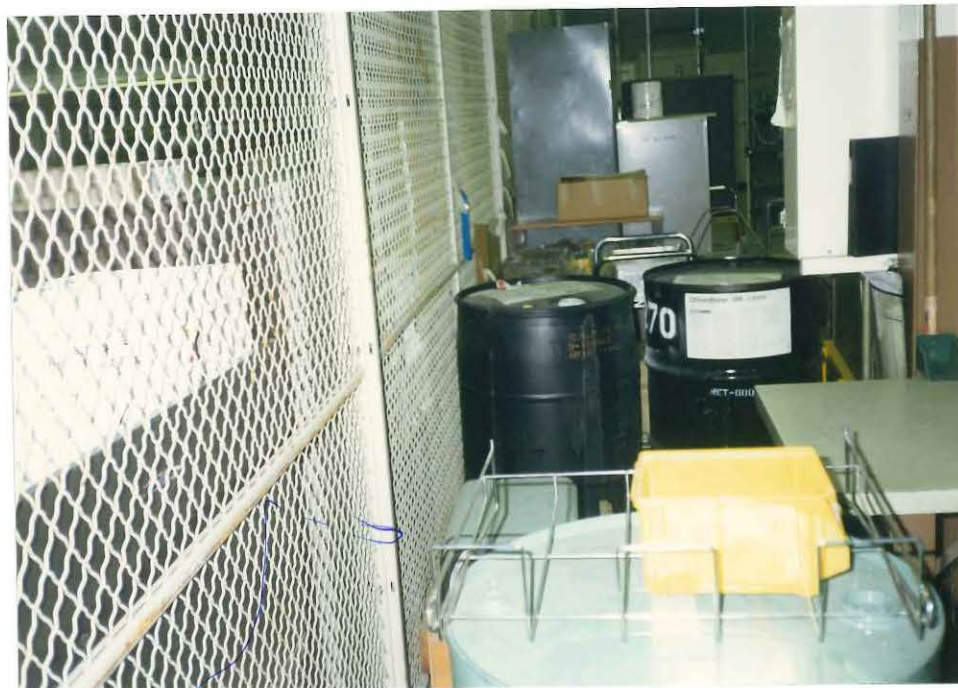
Photograph No. 19

**Observations:** The unit contained one 55-gallon drum of virgin 1,1,1-TCA and one 55-gallon drum of virgin flux during the VSI. The unit contained no waste. PRC noted no evidence of release (see Photograph No. 19).

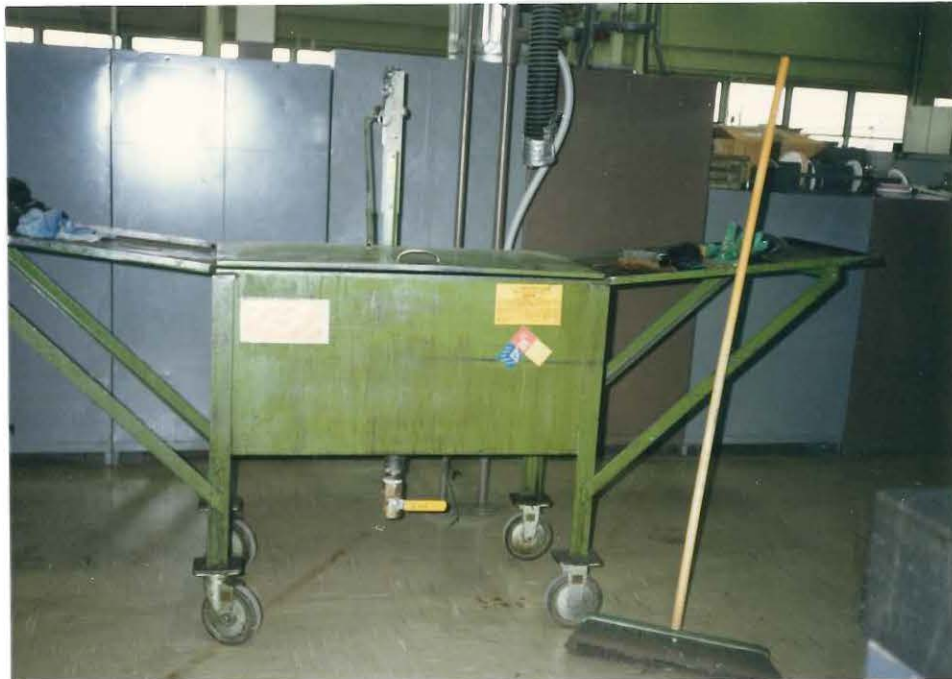
Photograph No. 21

During the VSI, the unit contained no waste. PRC noted some staining on the tile base of this unit. PRC observed no nearby floor drains (see Photographs No. 21 and 22).

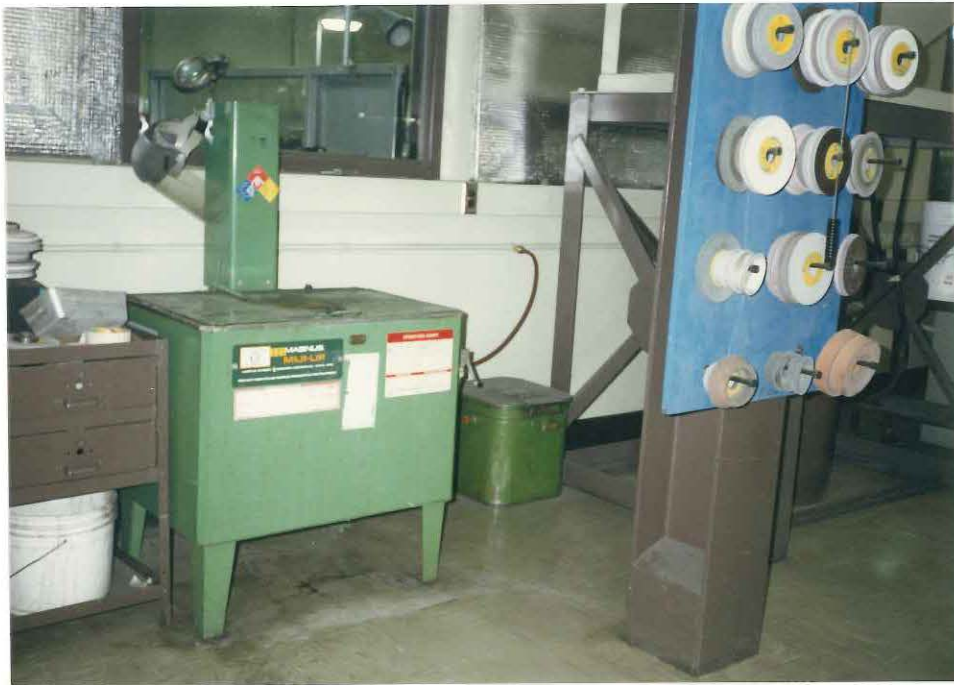
Photograph No. 22

Description: 12-gallon parts washer adjacent to SWMU 13; 55-gallon drum is periodically located on the right side of this parts washer

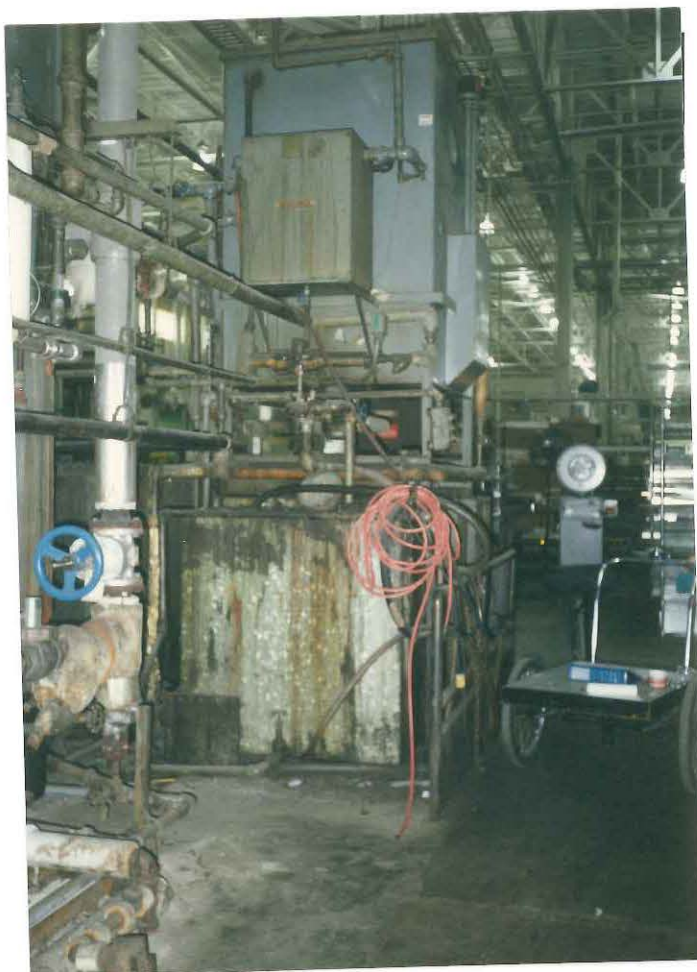
Photograph No. 23

unit did not contain a 55-gallon drum. PRC observed staining on the concrete base of the unit and on the sides of the tank (see Photograph No. 23).

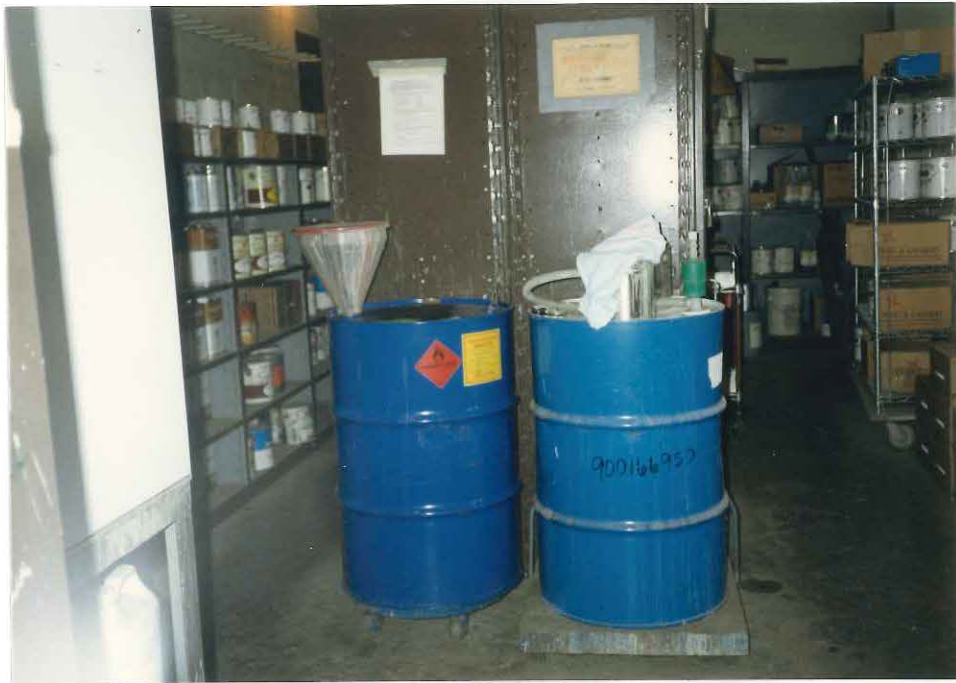
**Photograph No. 24**

The unit contained one partially filled 55-gallon drum of F005 waste paint. An adjacent 55-gallon drum contained detergent. PRC observed no evidence of release (see Photograph No. 24).

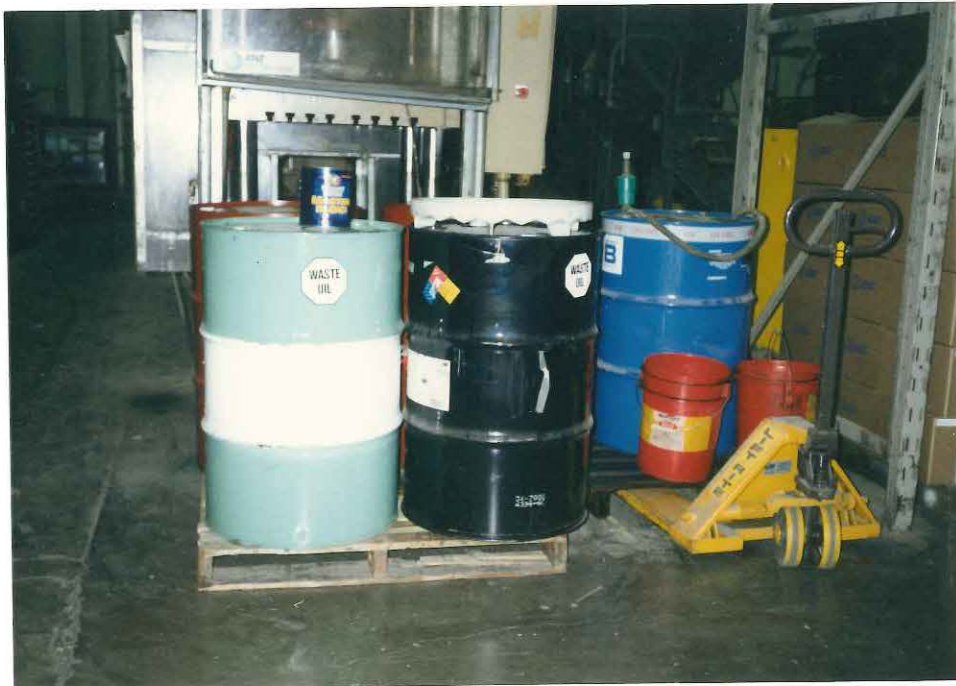
**Photograph No. 25**

**Observations:** This unit contained two 55-gallon drums of used oil. PRC noted no evidence of release (see Photograph No. 25).

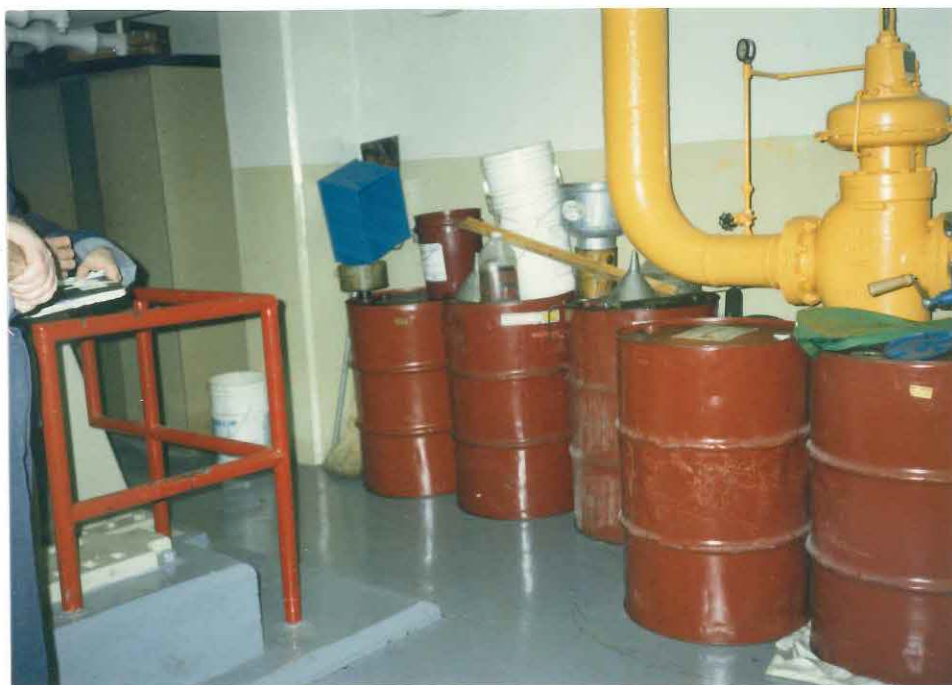
**Photograph No. 26**

**Description:** Boiler House Used Oil Accumulation Area (SWMU 17) containing one 55-gallon and one partially filled 55-gallon drum of used oil; two drums on left contain used oil, other drums contain virgin oil

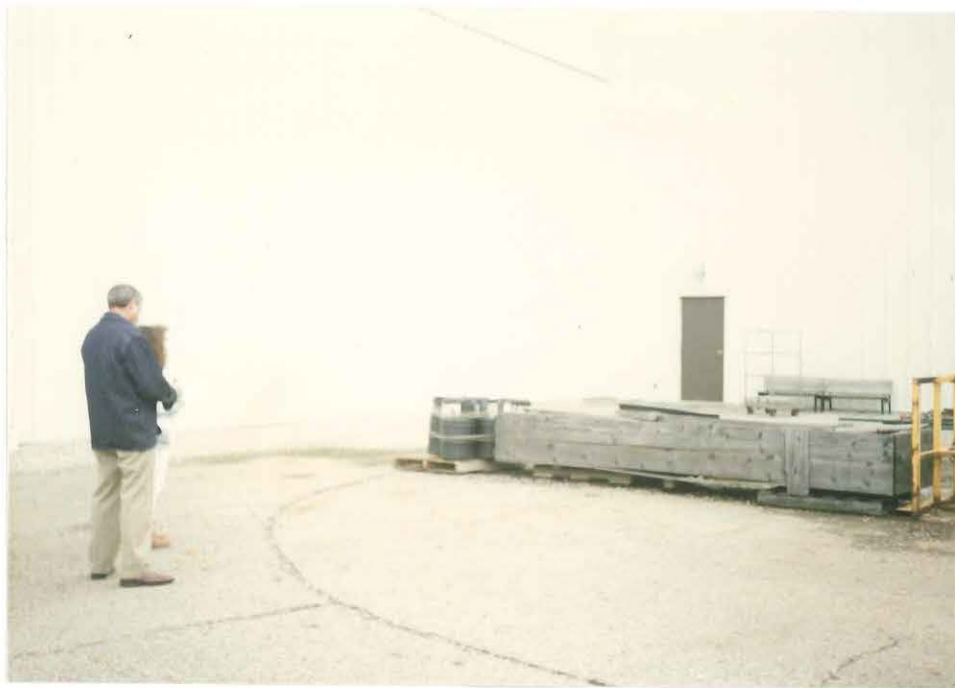
**Photograph No. 28**

asphalt and gravel. The area in which this unit was located is currently used for the storage of miscellaneous items (see Photograph No. 28).
